Assessment of prestressing effect in existing concrete bridges

Martin Moravcik ¹

¹ University of Zilina, Civil Engineering Faculty, martin.moravcik@uniza.sk,

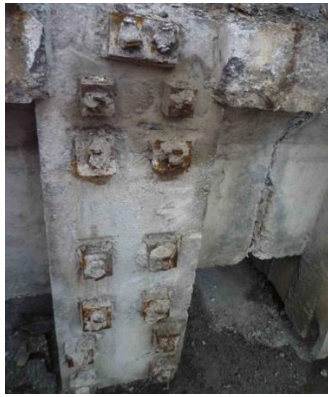
Figure 1a). No sheathing on the anchors – **Figure 1b).** Crack in the girders - Bridge Podbiel Bridge Nizna

In a recent period were declared state of emergency on two of precast prestressed concrete bridges crossing the river Orava on the international route I/59 closed the villages Podbiel and Nizna at north part of Slovakia. The emergency state was declared due to the serious failures on the bearing structure were detected. The first generation of prestressed bridges made of precast elements began to be applied more extensively in the former Czechoslovakia during the 1950s to 1960s. The actual technical condition of the observed bridges has been manifest as the cause of the initial “childhood diseases” of building technology. As the main source of the failure state of this type has been total insufficient protection of prestressing reinforcement and anchors. For example, tendons were found very poor grouted and anchors were detected with insufficient or none concrete sheathing, see Fig. 1a). All these facts had been the crucial influence to the large deformation rising or wide crack opening in the girders, Fig. 1b).

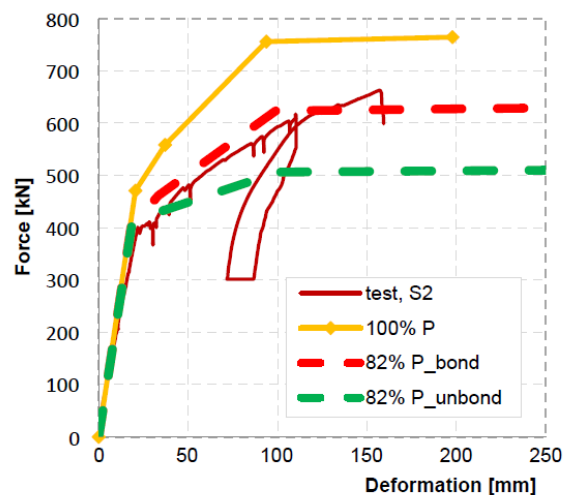
One girder in relatively good technical condition was separated from orthotropic bridge deck (bridge Podbiel) and was full-scaled tested. There was obtained about 18 % reduction of assumed prestressing force in the girder.

Figure 1. Bridge Podbiel - reduction of prestressing force in girder about 18%.

Detected structural failures had been depended to the actual prestressing level as we know. To define the actual prestressing force in existing structures is very difficult task. Generally there are available any kind of destructive or non-destructive method but still complicated to use. We had used analytical and experimental approach in the form of Structure Response Method. In this abstract, we would like to present the results of performed testing method of prestressing, based on the fully scaled loading test and numerical analyses of deteriorated structure. Some result can be seen on prestressed girder on the Bridge Podbiel, Fig. 2.
